FINAL REPORT

**A STUDY OF HYDROGEN EMBRITTLEMENT
OF VARIOUS ALLOYS**

**NATIONAL AERONAUTICS AND SPACE
ADMINISTRATION
GEORGE C. MARSHALL
SPACE FLIGHT CENTER**

T. P. Groeneveld, E. E. Fletcher, and A. R. Elsea

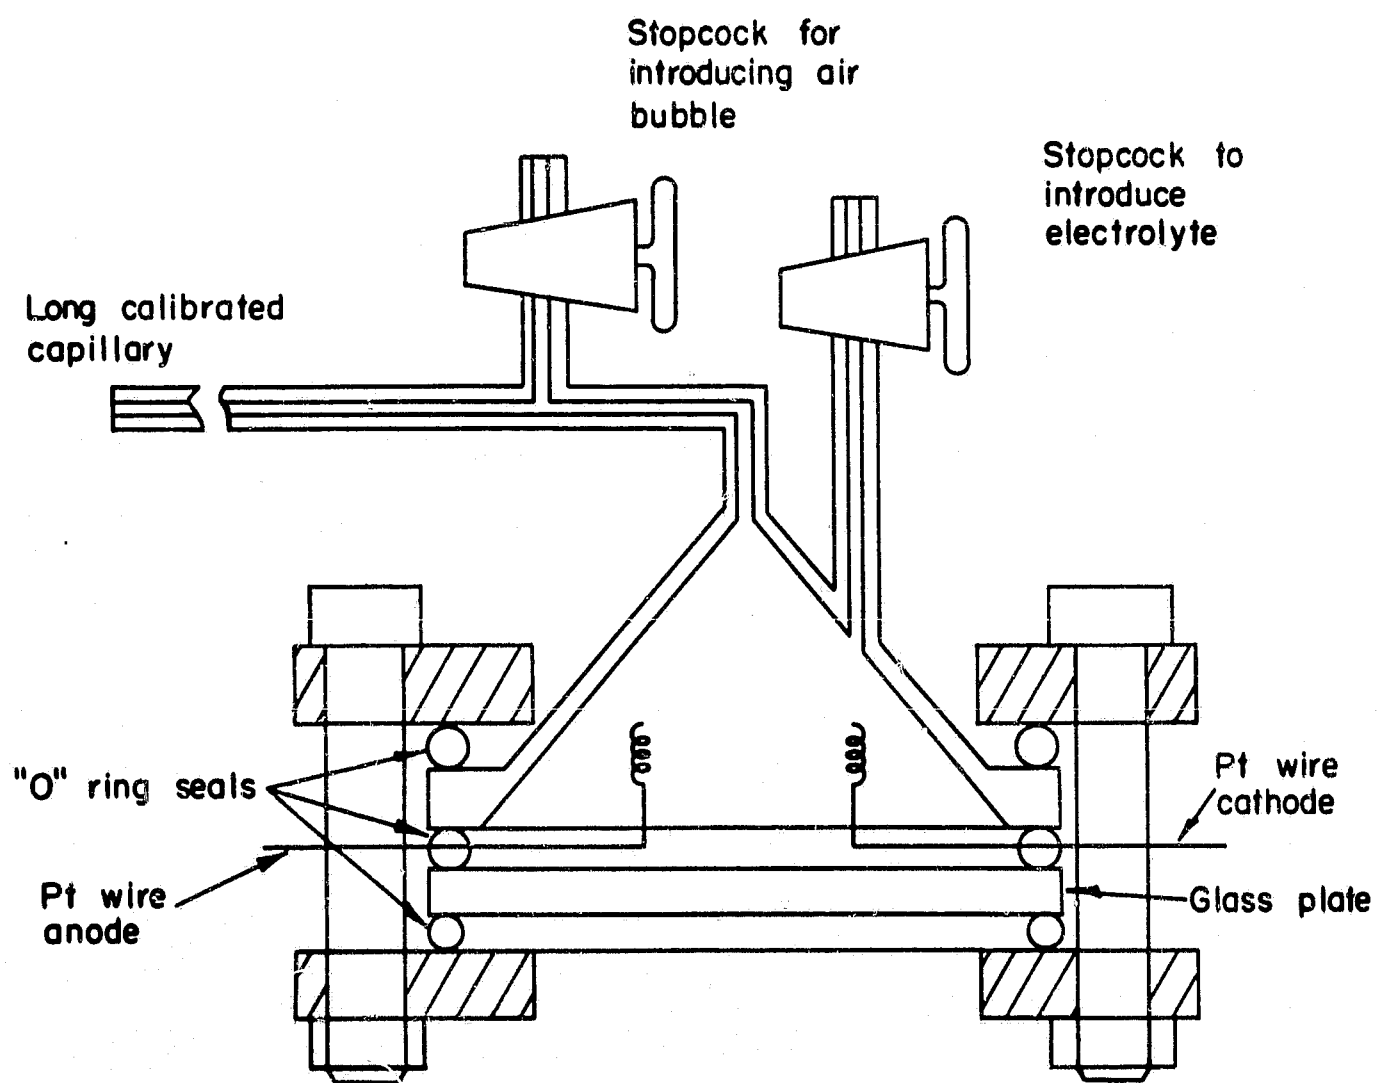
FIGURE 1. CURRENT EFFICIENCY CELL

Hydrogen-entry-rate experiments also were conducted to determine whether the rate at which a material accepts hydrogen is directly related to its susceptibility to hydrogen-stress cracking. These experiments were conducted using the apparatus shown in Figures 1 and 2. The apparatus consists of two cells of equal volume with a calibrated capillary tube attached to each cell. The cells and capillary tubes are filled with electrolyte, and bubbles are introduced into the tubes for reference purposes. Displacement of the electrolyte, which results from gas evolution caused by electrolysis in the cells, can be measured by the displacement of the bubbles in the capillary tubes.

Since the cells are connected electrically in series, the current flowing through them is identical and, therefore, with the same electrolyte the volume of gases produced by electrolysis should be the same in each cell. The current-efficiency cell, shown schematically in Figure 1, contains a platinum anode and a platinum cathode saturated with hydrogen; this cell measures the total volume of gas produced by electrolysis. The hydrogen-entry cell, shown schematically in Figure 2, contains a platinum anode, and the material under study serves as the cathode. Since the only difference in the cells is the material that constitutes the cathode, the difference between the displacement of the bubbles in the capillary tubes of the respective cells indicates the amount of hydrogen entering the specimen as a function of time.

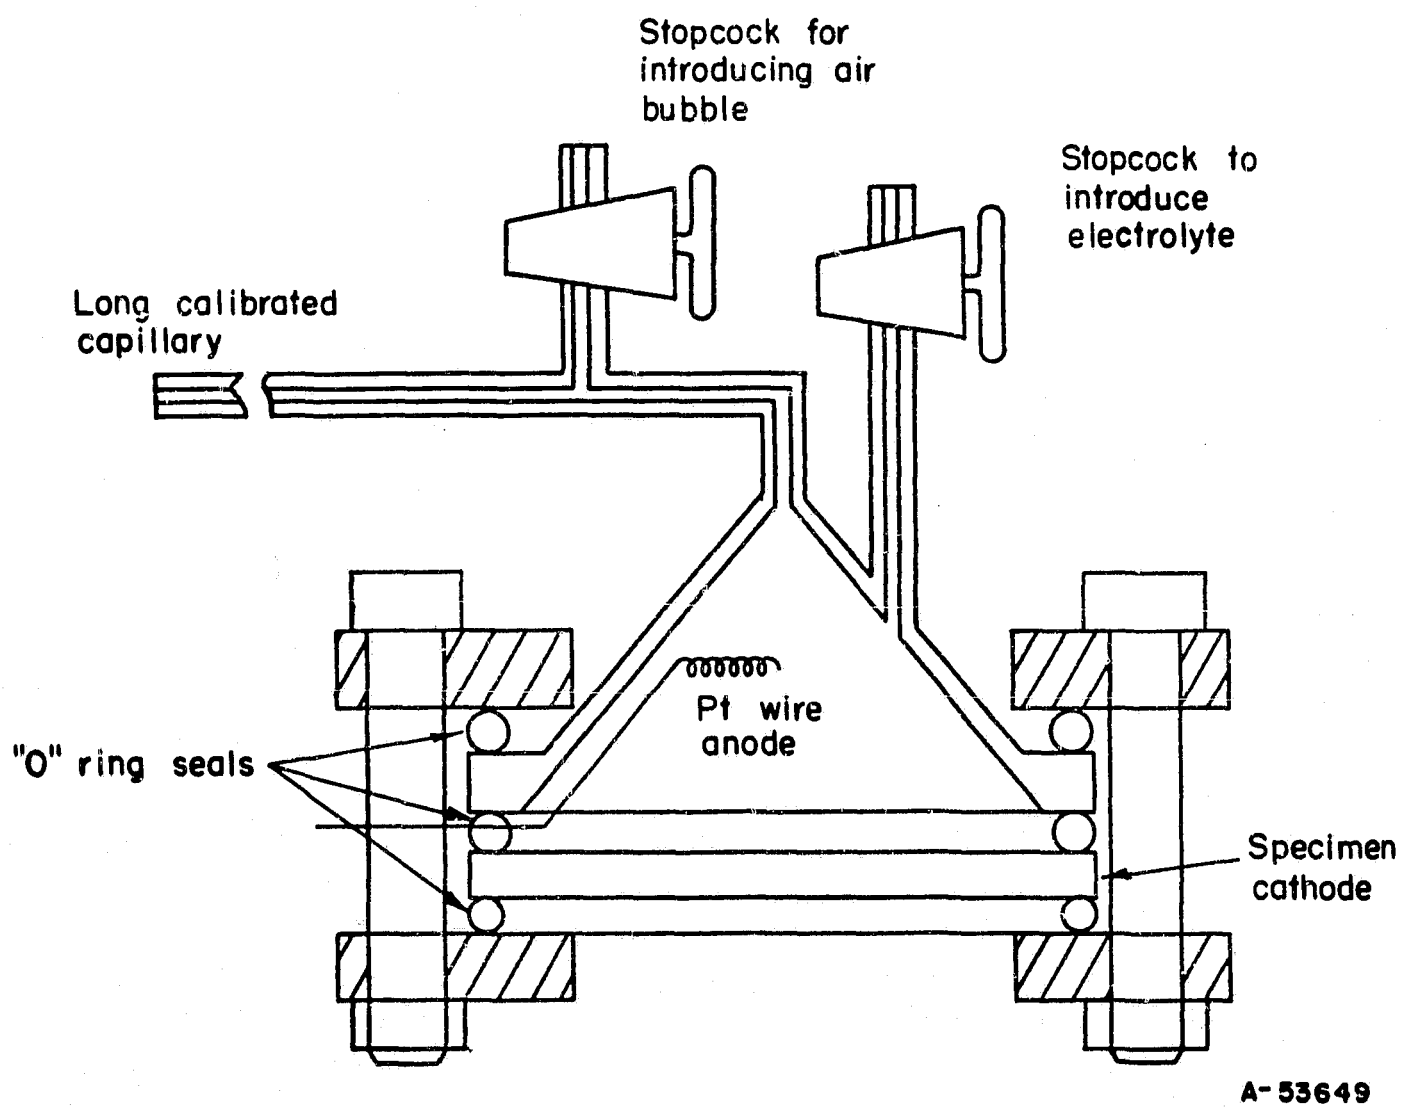
FIGURE 2. HYDROGEN ENTRY CELL

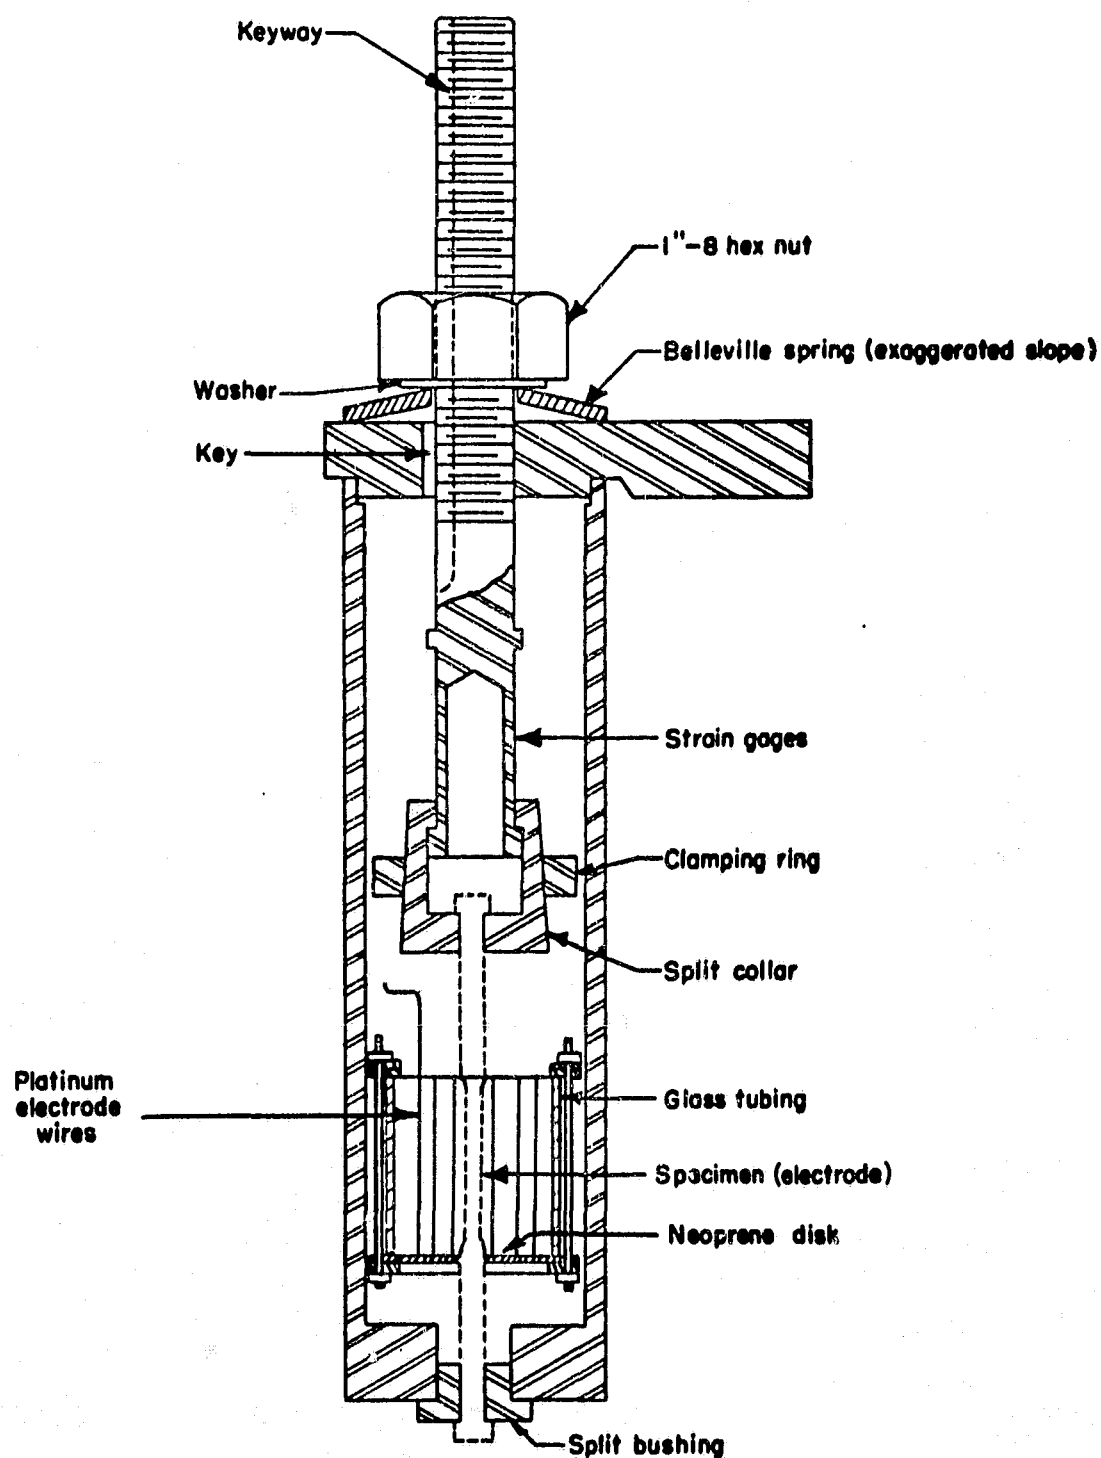
FIGURE 6. APPARATUS EMPLOYED IN THE SUSTAINED-LOAD EXPERIMENTS

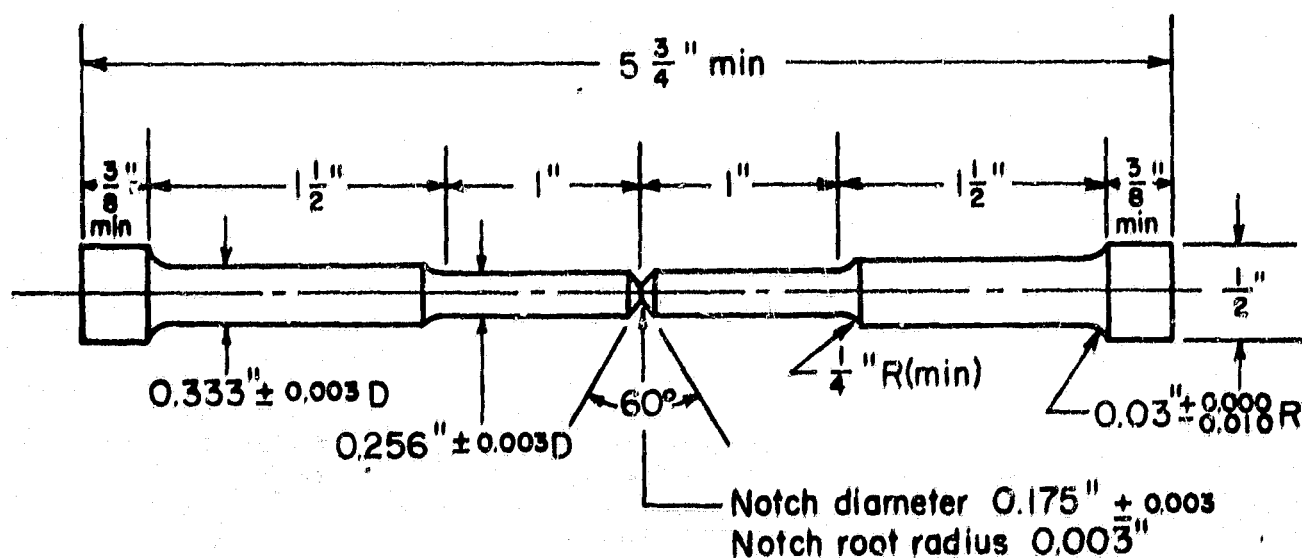
FIGURE 7. DETAILS OF THE NOTCHED TENSILE SPECIMENS USED TO EVALUATE THE SUSCEPTIBILITY OF Ti-6Al-4V TO HYDROGEN-STRESS CRACKING

For the reevaluation, it was decided to pickle notched tensile specimens of Ti-6Al-4V in aqueous solutions with different concentrations of hydrofluoric acid and in a conventional nitric acid-hydrofluoric acid pickling bath. Pickling in the HF baths would promote hydrogen pickup, while pickling in the HNO₃-HF bath would allow evaluation of a conventional pickling process. The specimen used is shown in Figure 7.

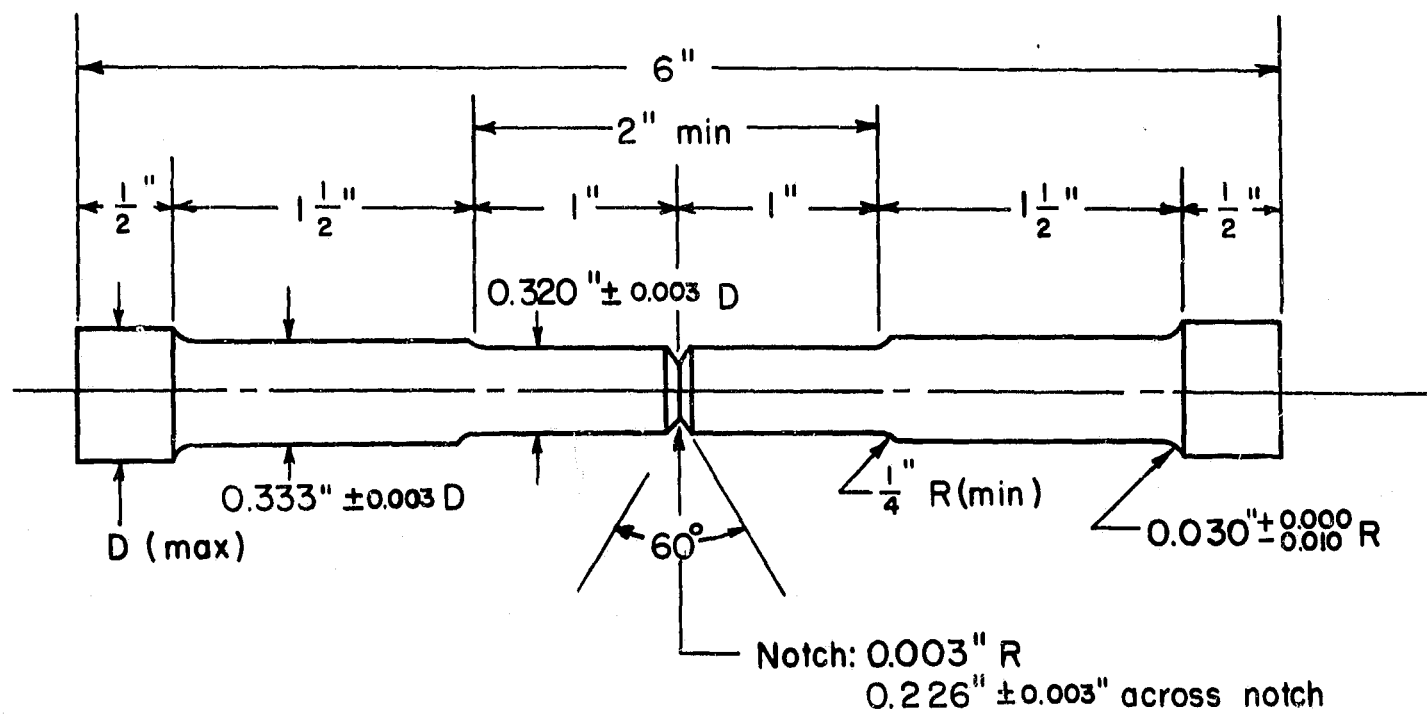
FIGURE 8. DETAILS OF THE NOTCHED TENSILE SPECIMEN USED IN THE SUSTAINED LOAD EXPERIMENTS

The remaining 133 heat-treated blanks were machined into notched tensile specimens according to the dimensions shown in Figure 8. The notch diameters and notch-root radii of these specimens were checked using a shadow comparator at 50X. Those specimens in which the notch diameter or notch-root radius was outside the tolerances were ground into smooth bars, 0.320 inch in diameter, which were subsequently sectioned into 7/8-inch-long coupons to be used as specimens for hydrogen analyses.

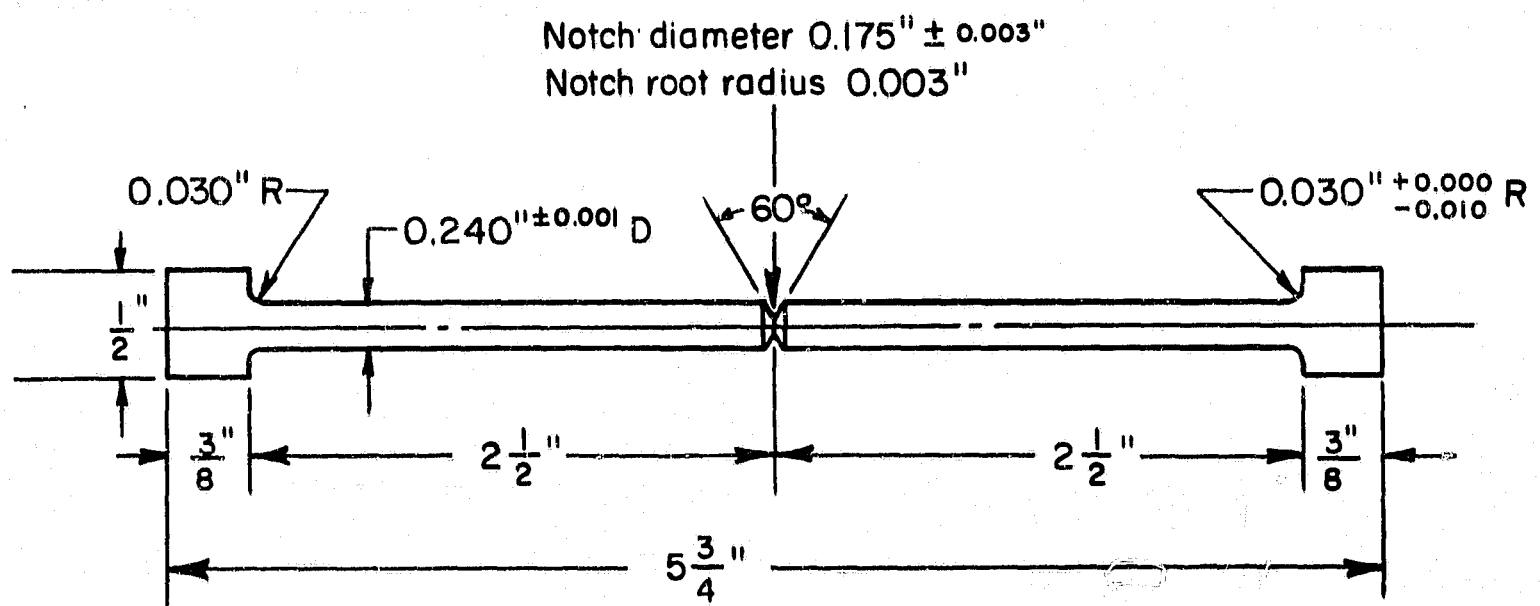
FIGURE 9. DETAILS OF THE NOTCHED TENSILE SPECIMENS USED TO EVALUATE THE SUSCEPTIBILITY OF CLEANED AND ELECTROPLATED AISI TYPE 410 STAINLESS STEEL TO HYDROGEN-STRESS CRACKING

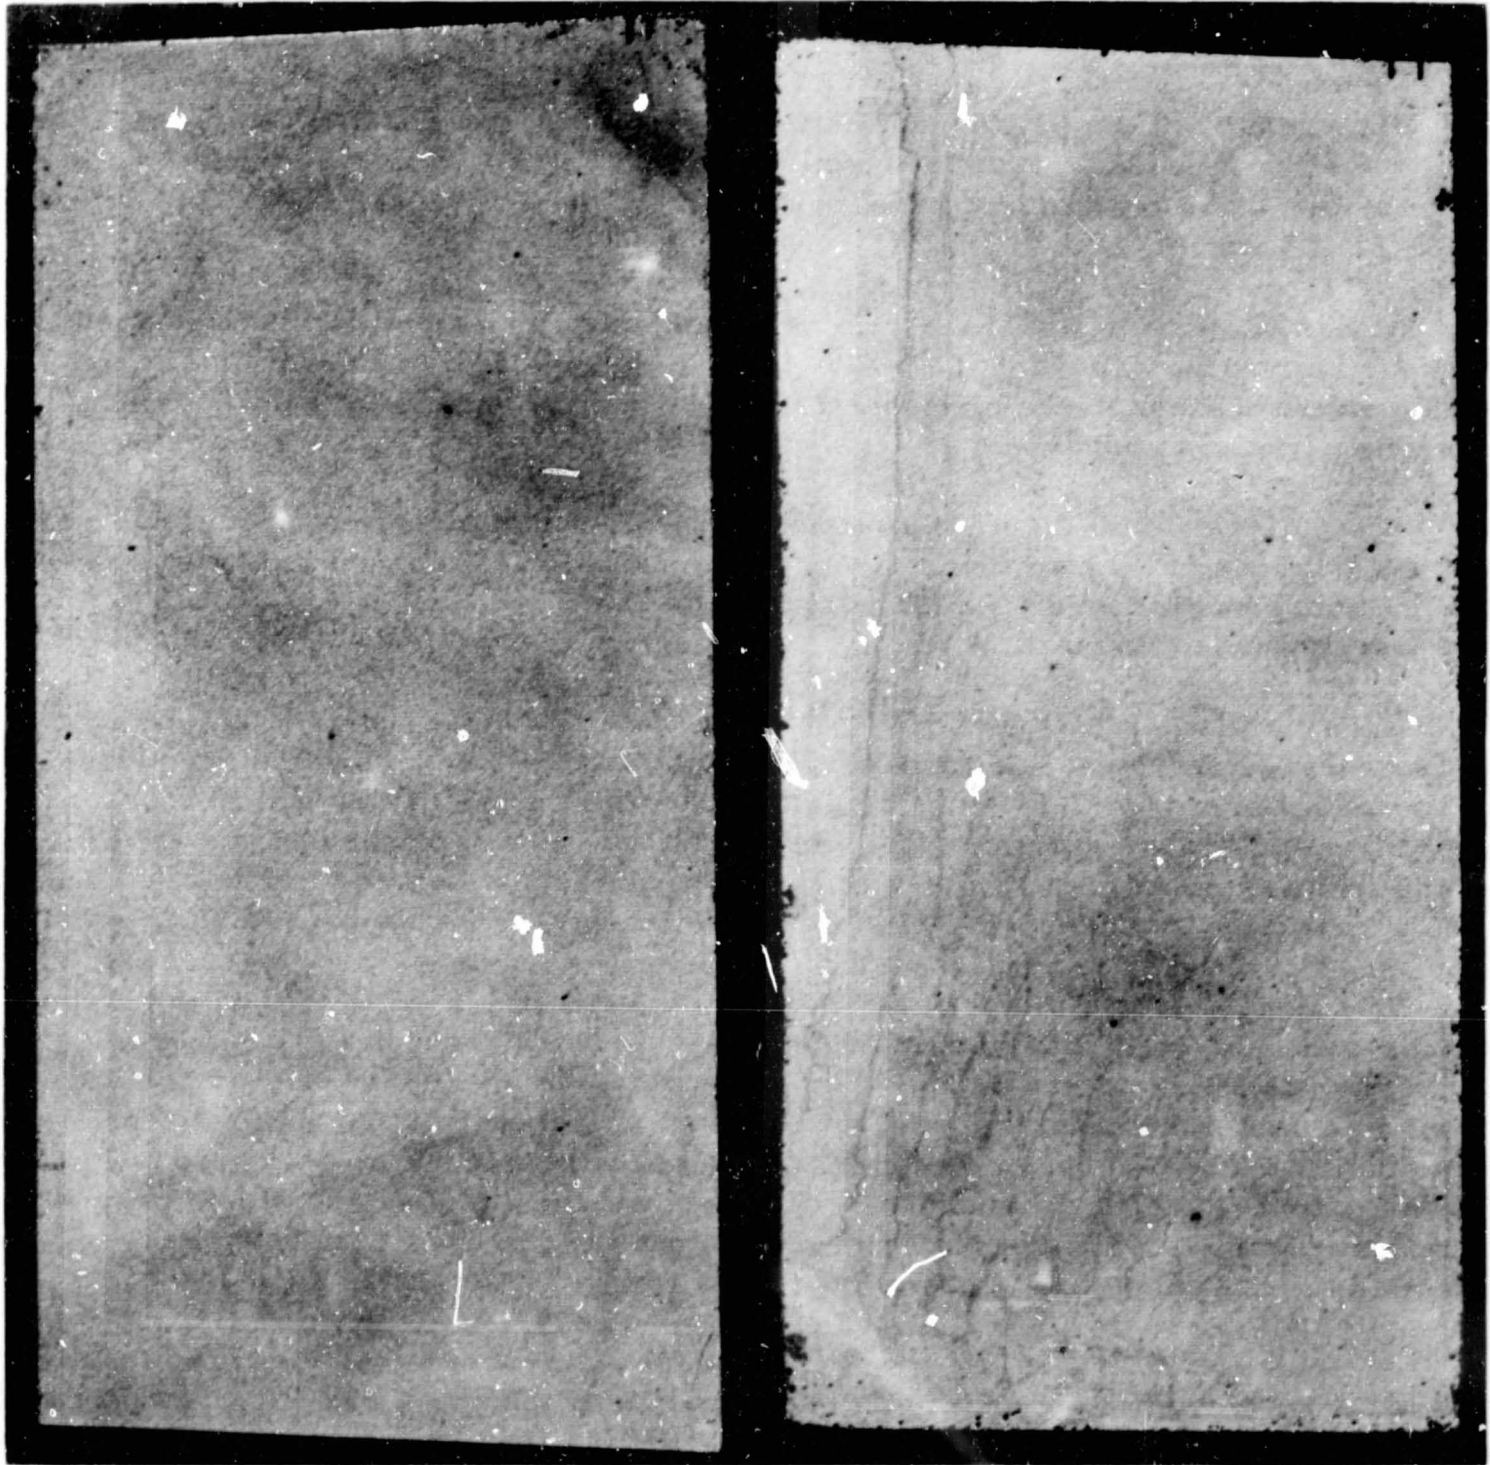
FIGURE 10. BRIGHT-CADMIUM-ELECTROPLATED PANELS PRIOR
TO EXPOSURE TO SALT SPRAY

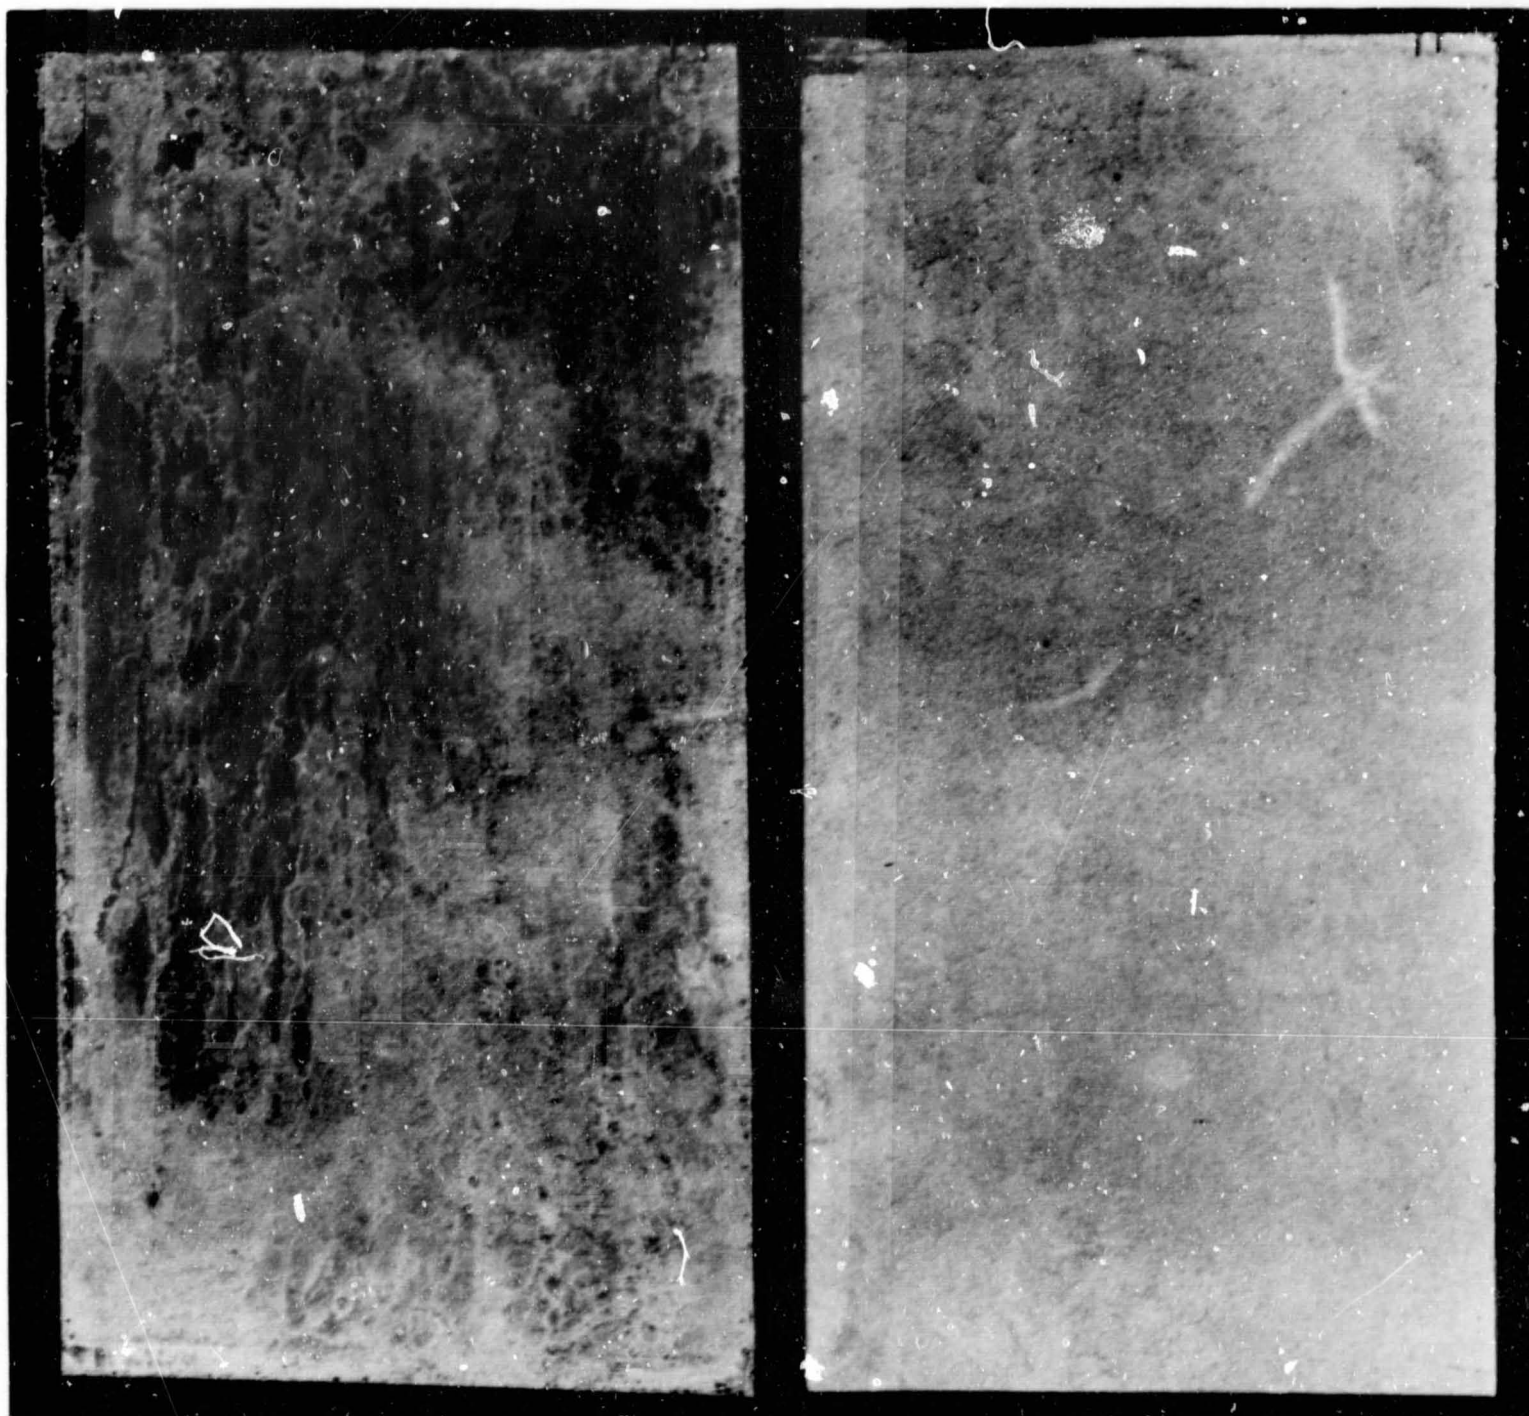
FIGURE 11. BRIGHT-CADMIUM-ELECTROPLATED PANELS AFTER 240-HOUR EXPOSURE TO SALT SPRAY

No evidence of corrosion of base metal is observed.

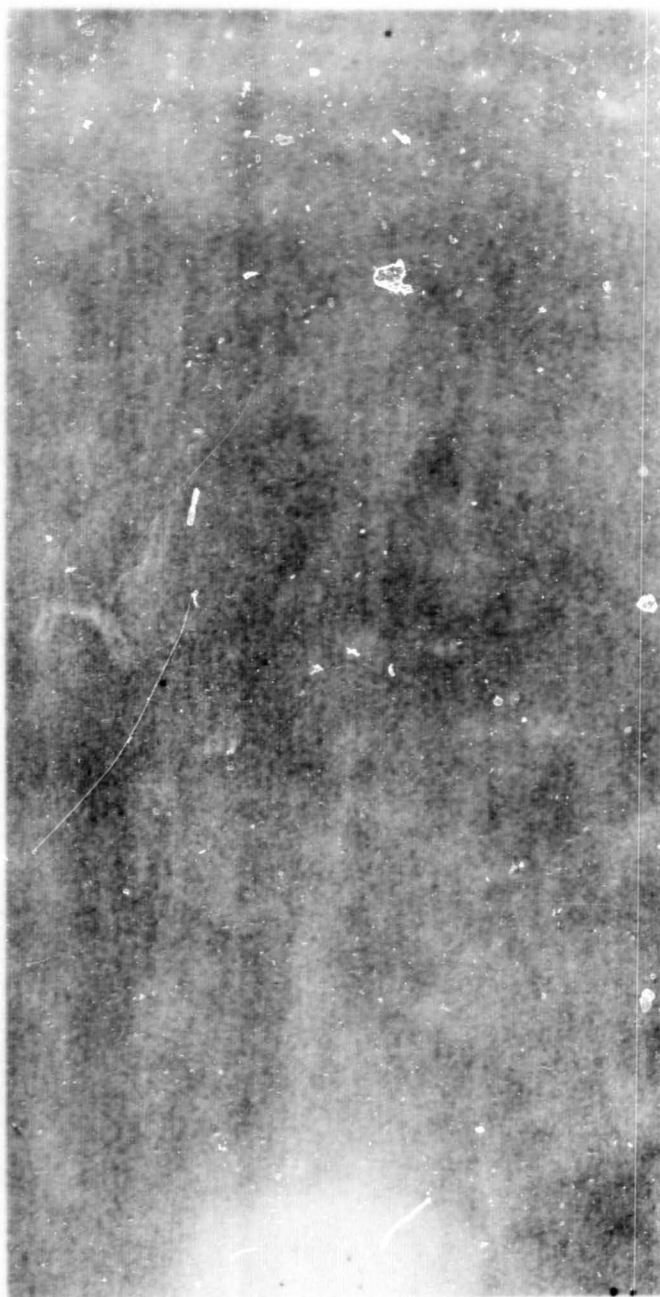
FIGURE 12. DULL-CADMIUM-ELECTROPLATED
PANEL PRIOR TO SALT-SPRAY
EXPOSURE

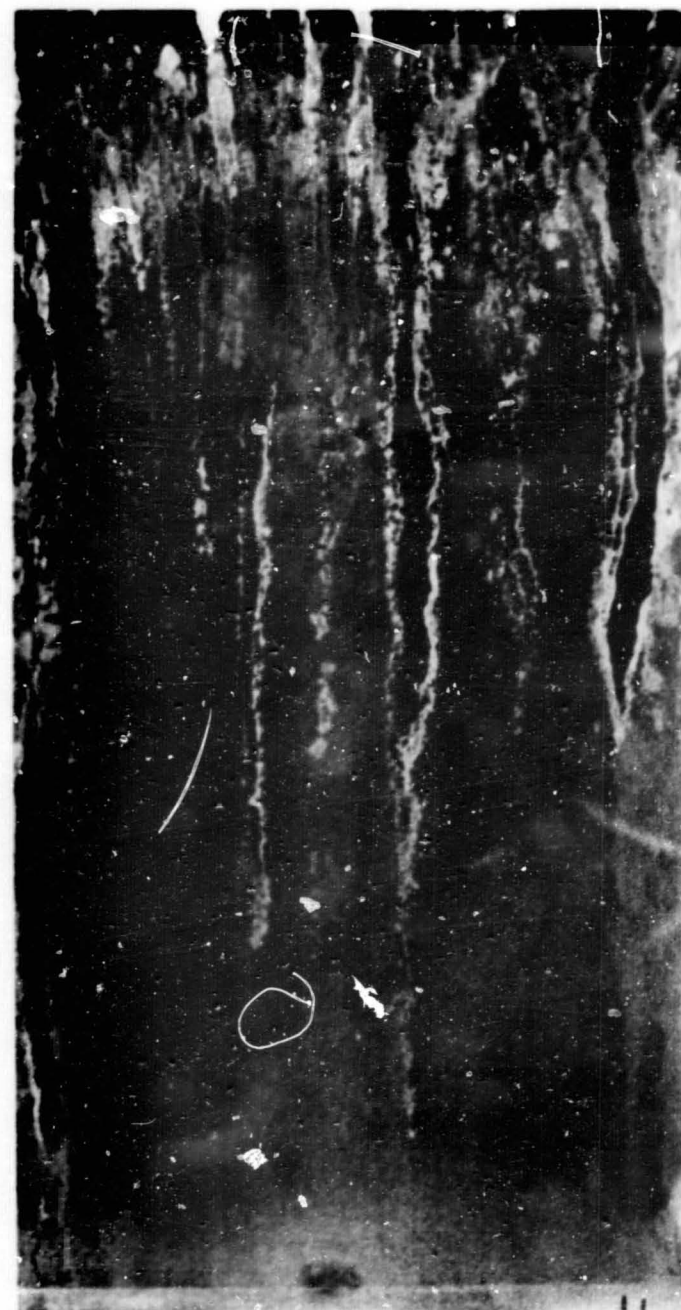
FIGURE 13. DULL-CADMIUM-ELECTROPLATED
PANEL AFTER 240-HOUR SALT-
SPRAY EXPOSURE

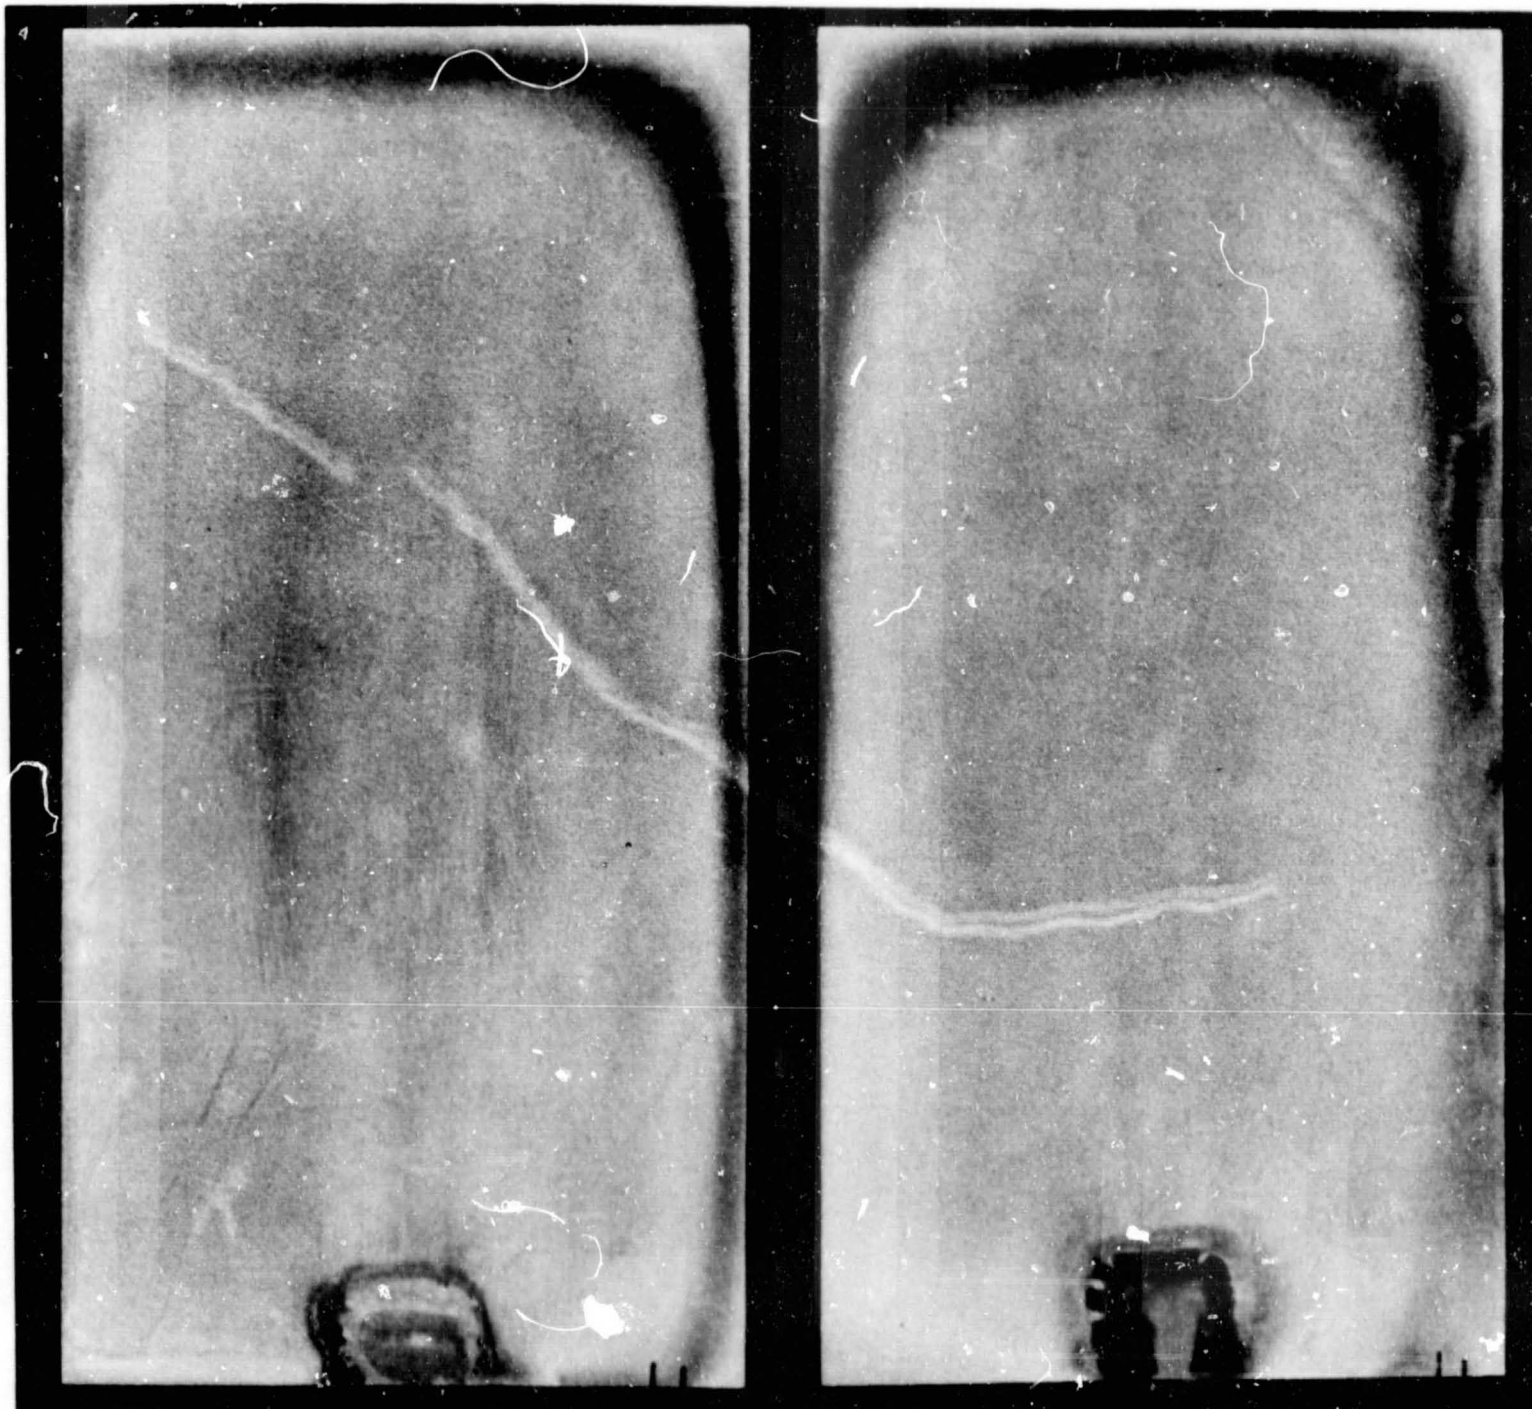
FIGURE 14. Cd-Ti(Delta)-ELECTROPLATED PANELS PRIOR TO SALT-SPRAY EXPOSURE

The samples are pictured prior to application of the electroplater's tape over unplated areas where the clips were attached.

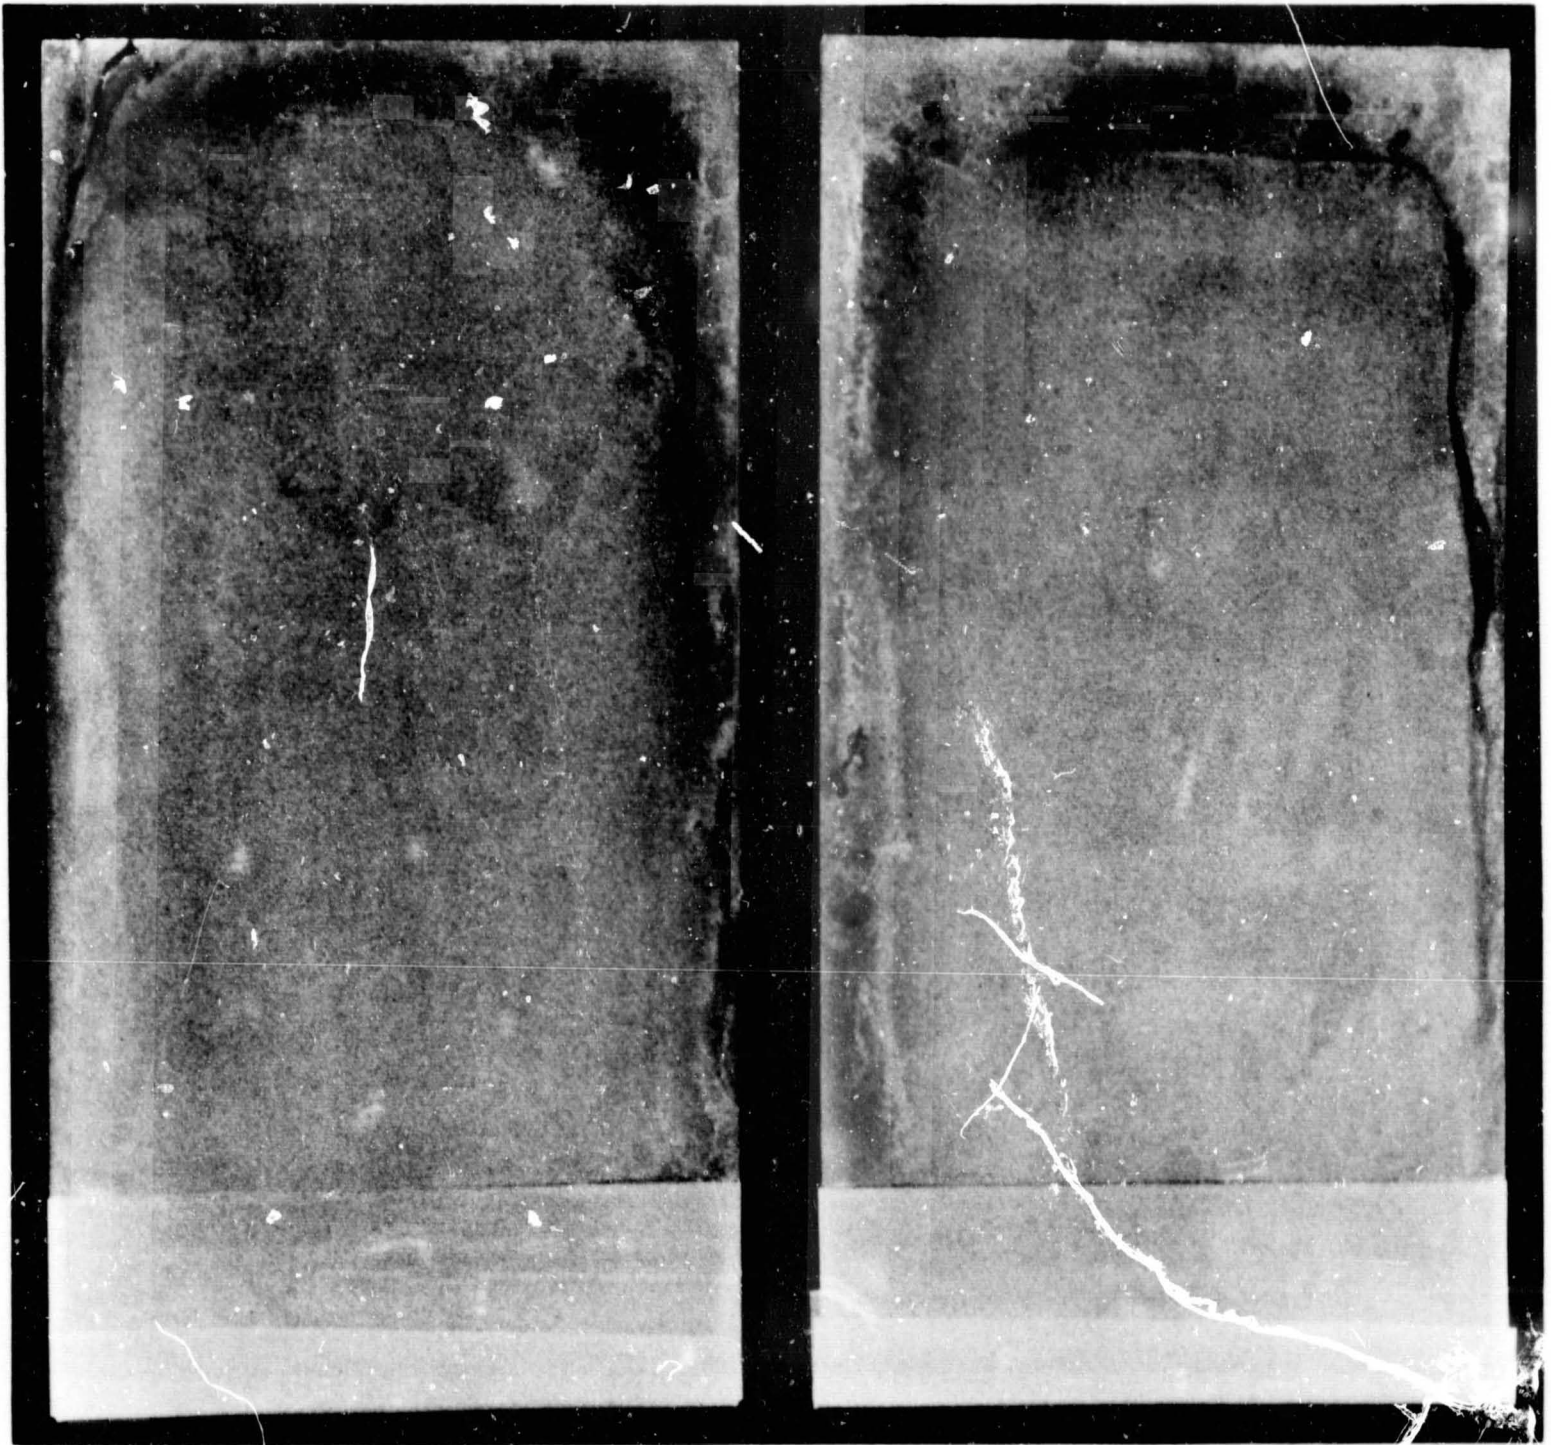
FIGURE 15. Cd-Ti(Delta)-ELECTROPLATED PANELS AFTER 336-HOUR EXPOSURE TO SALT SPRAY

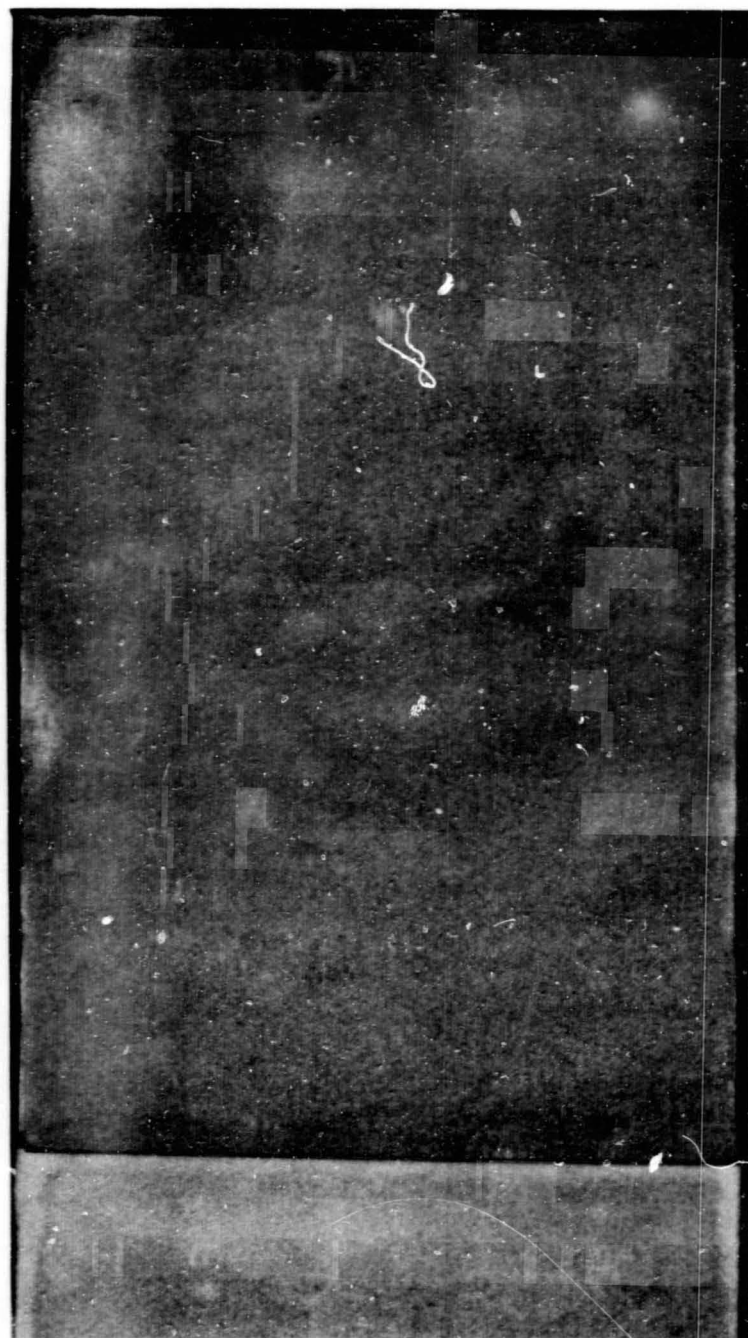
FIGURE 16. CADMIUM ACETATE-METHANOL-ELECTROPLATED PANEL PRIOR TO SALT-SPRAY EXPOSURE

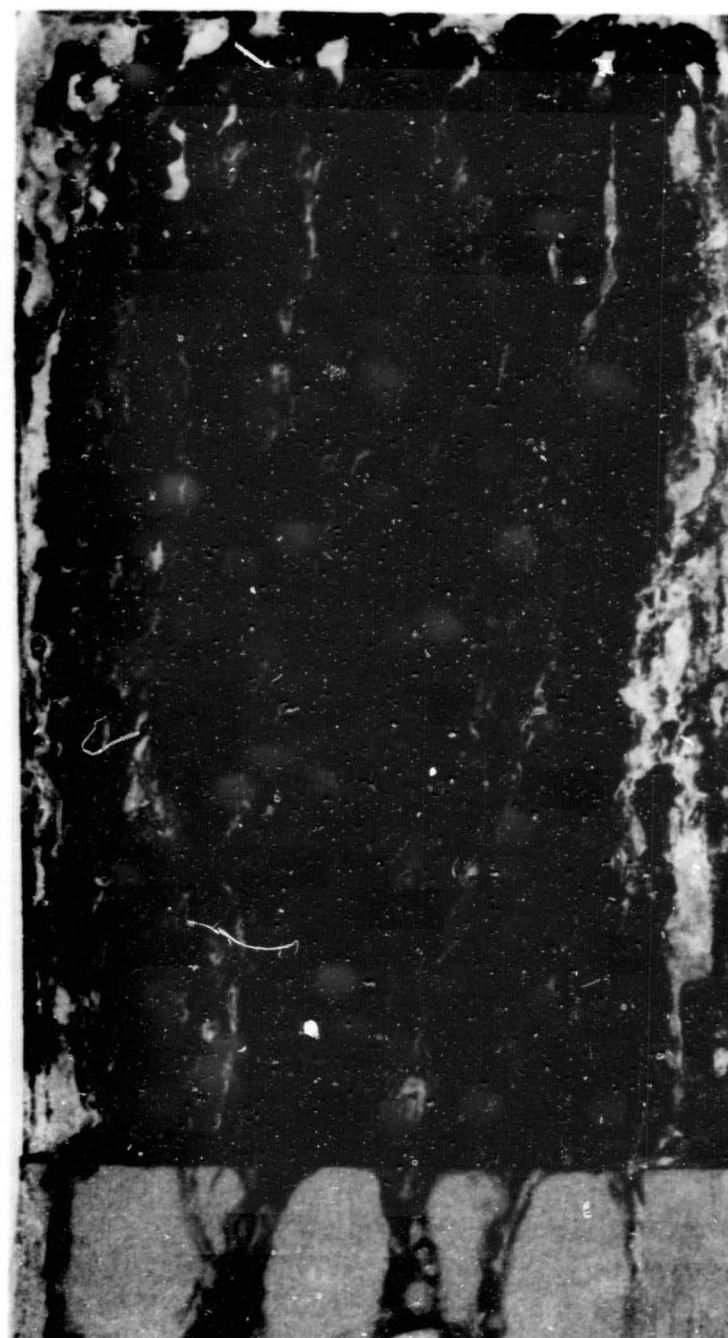
FIGURE 17. CADMIUM ACETATE-METHANOL-ELECTROPLATED PANEL AFTER 96-HOUR SALT-SPRAY EXPOSURE

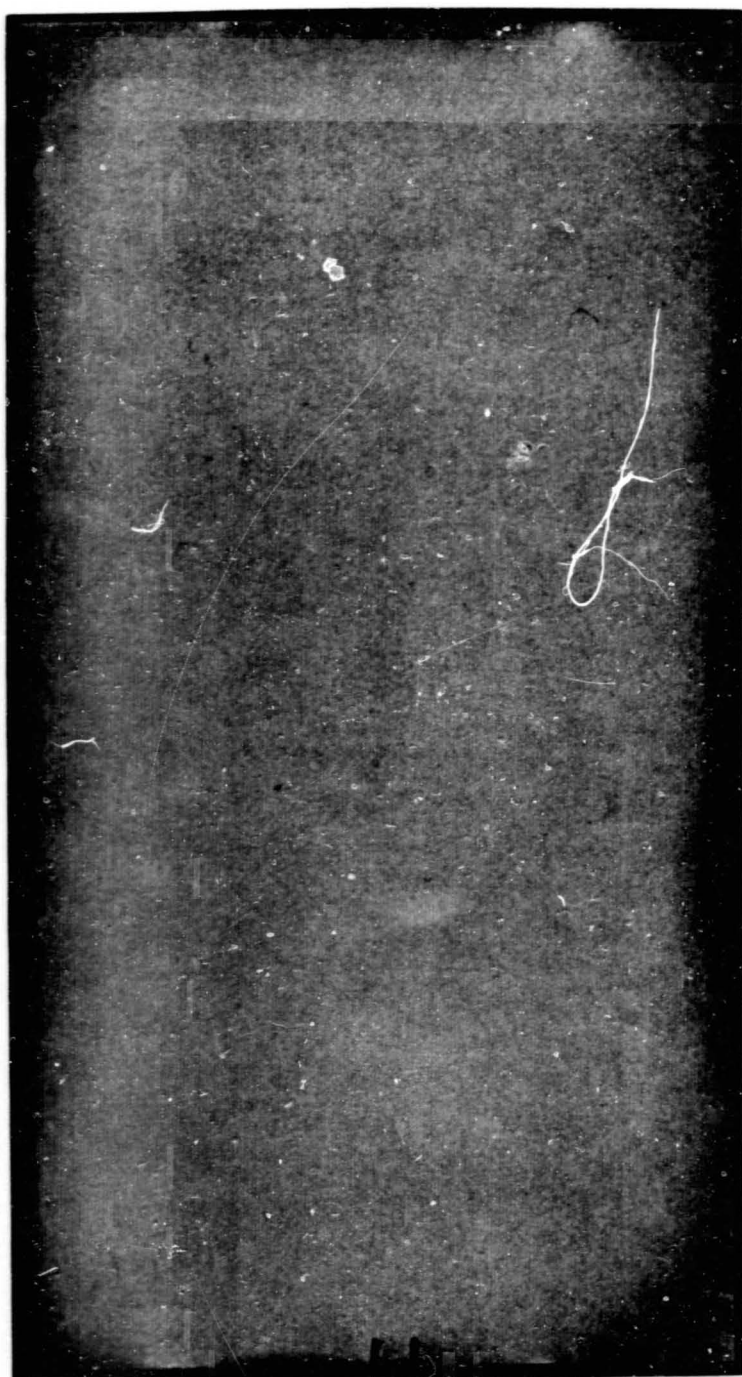
FIGURE 18. PANEL ELECTROPLATED IN THE STABLE CYANIDE-CADMIUM BATH PRIOR TO SALT-SPRAY EXPOSURE

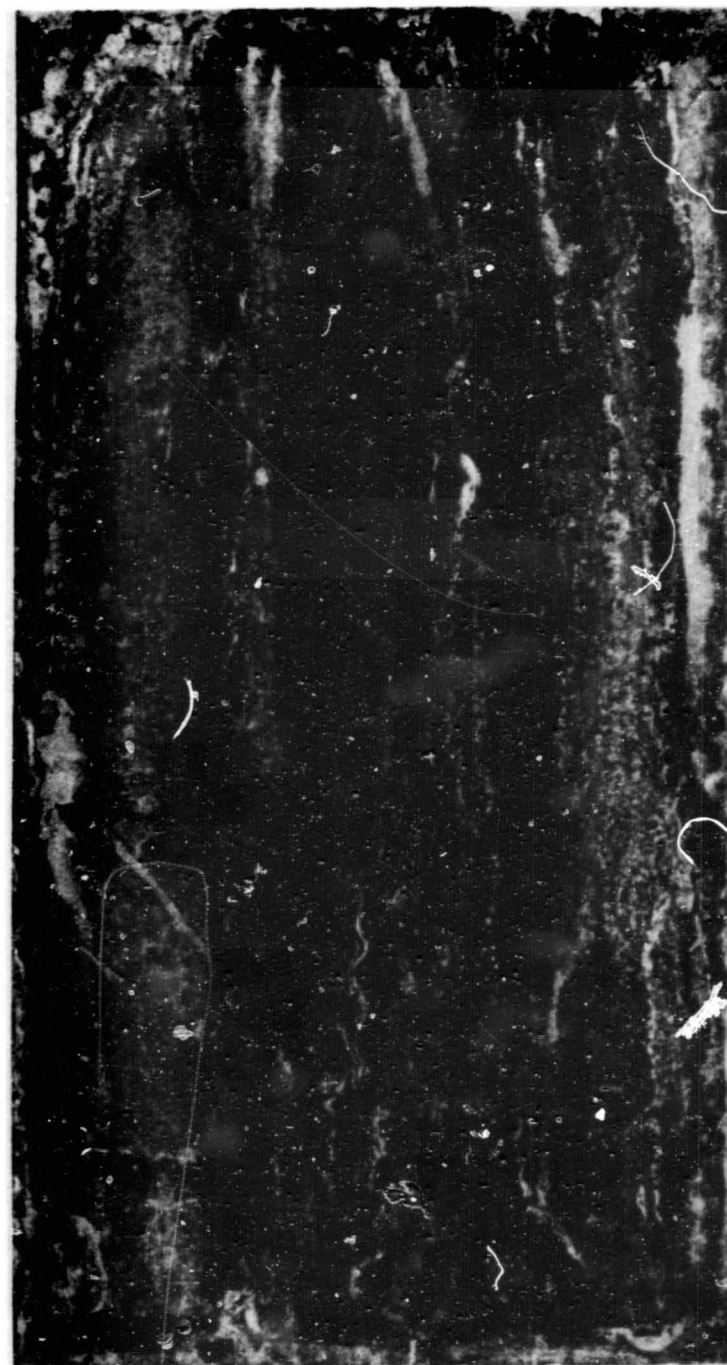
FIGURE 19. PANEL ELECTROPLATED IN THE STABLE CYANIDE-CADMIUM BATH AFTER 240-HOUR SALT-SPRAY EXPOSURE
